Event V: Finish Mill Blaine Deviation

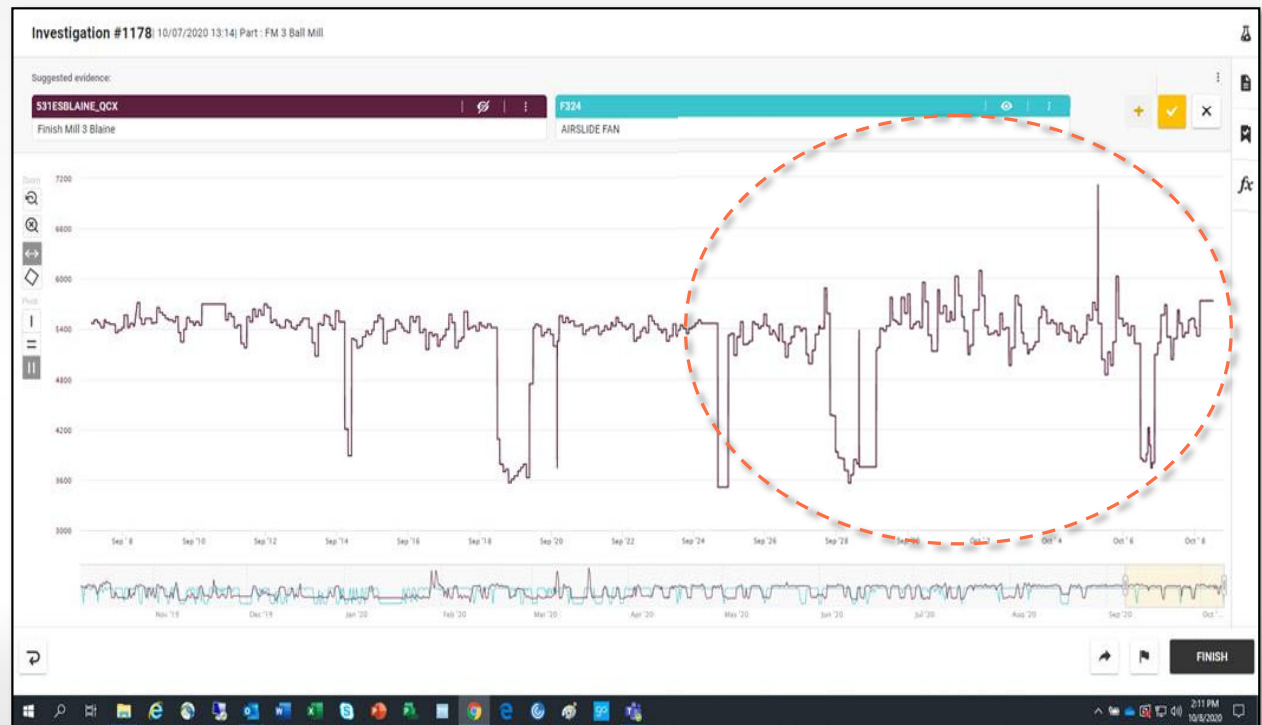
- Cement Blaine deviation increased significantly
- No indications nor alarms in the plant control room

- Feed clinker mix had been changed. Increased ground clinker percentage had resulted to feeding flowability issues and eventually to increased Blaine deviation

- Avoid quality issues and restore proper feeding by reviewing clinker mix and optimizing with respect to feeding flowability and Blaine deviation targets
