Event I: Kiln Pier #1 Oil Temp - Lubrication

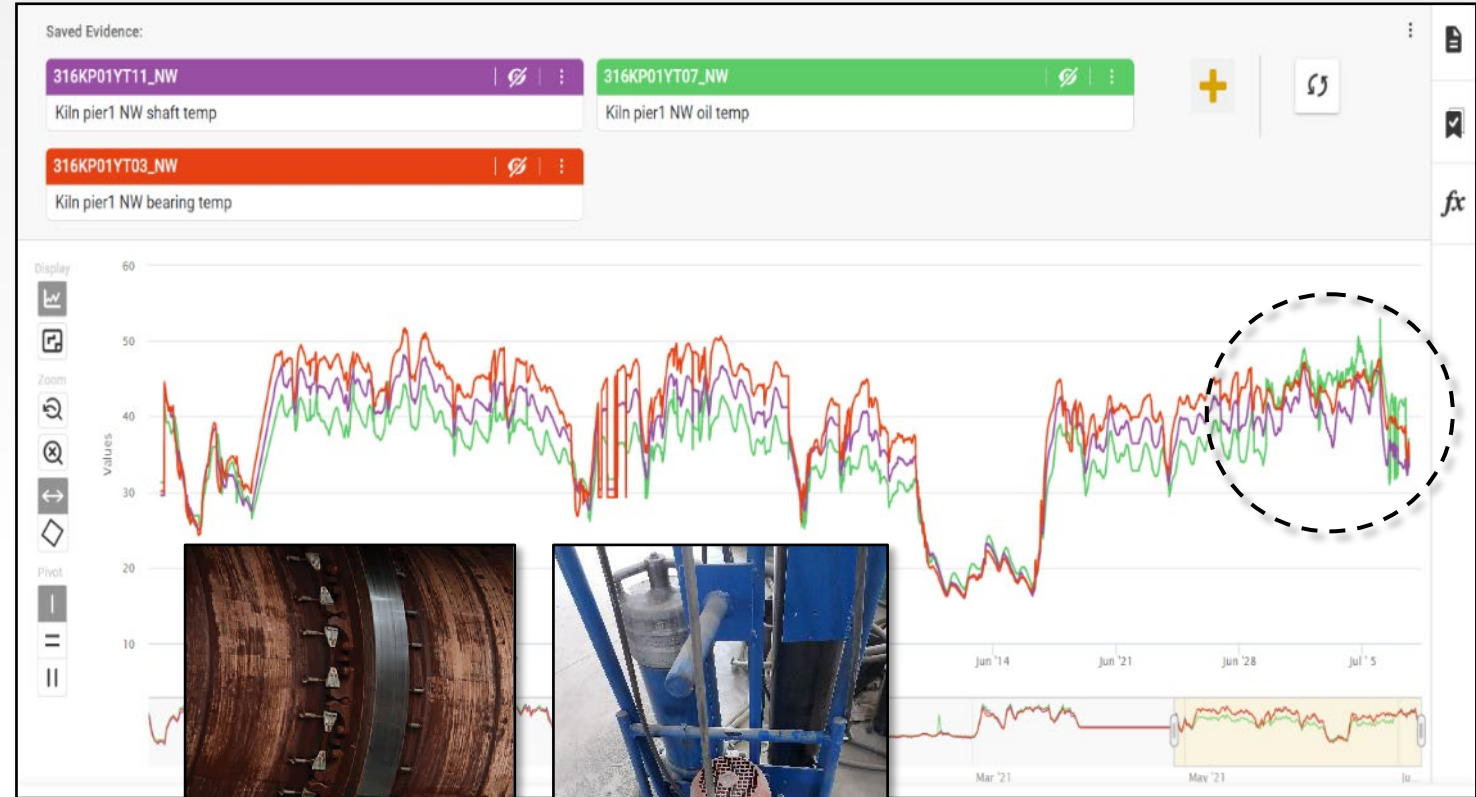
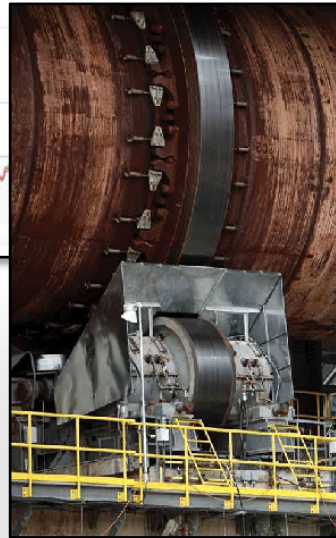
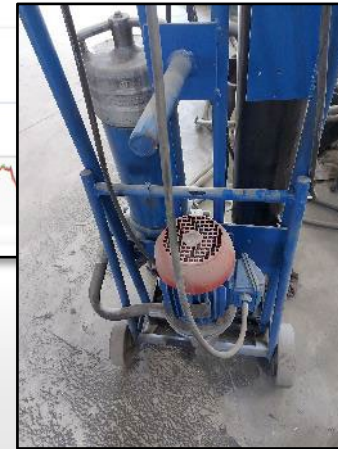
- Temperature increase in Pier #1 of kiln (still within limits)
- No indications nor alarms in the plant control room

- External oil leakage was found at the oil cooler.
- Bearing still not dry and oil level still in operational range (no level alarm triggered)
- Plant team isolated the cooler and refilled oil tank.
- Oil cooler replaced and full operation was restored

- Field inspection of lubrication system and cooling system for leakages, flow or potential contamination issues. On-site inspection of instrumentation.

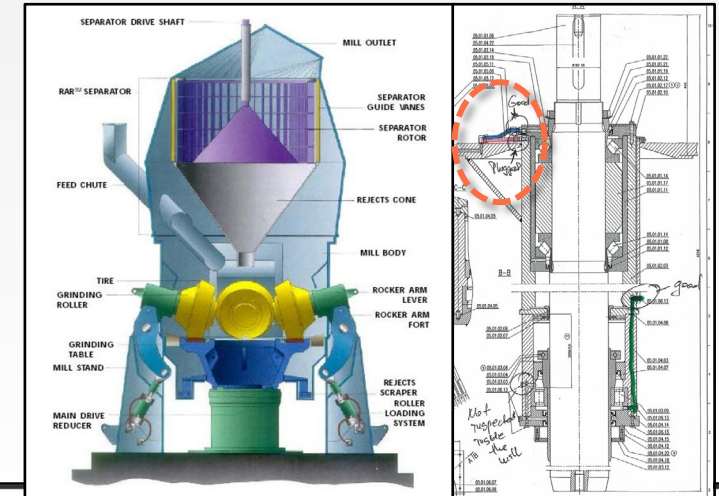
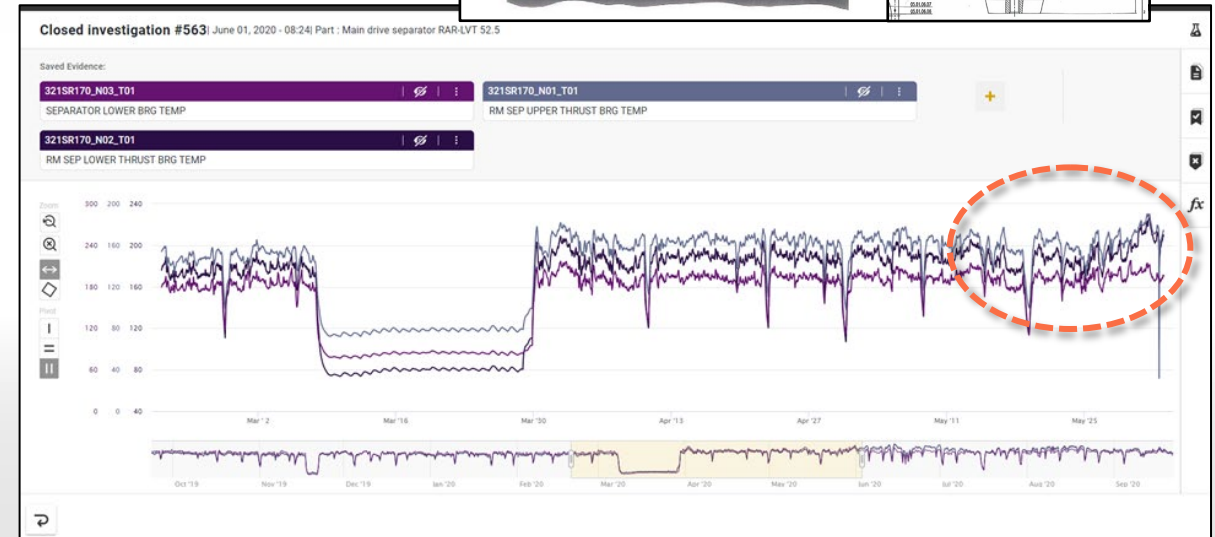
- Moderate temperature increase in separator shaft bearings
- No indications (alarms) in the plant control room

- Grease distributor was found clogged and was replaced
- Temperature still elevated so it was suggested to disconnect all lines and check if lubricant is flowing
- One of the grease lines was found clogged and cleaned
- Bearing temperature back to normal levels
- Bearing damage avoided b/c event was captured at very early stages

- Inspect automatic lubrication system
- Check for unusual vibration levels or noise

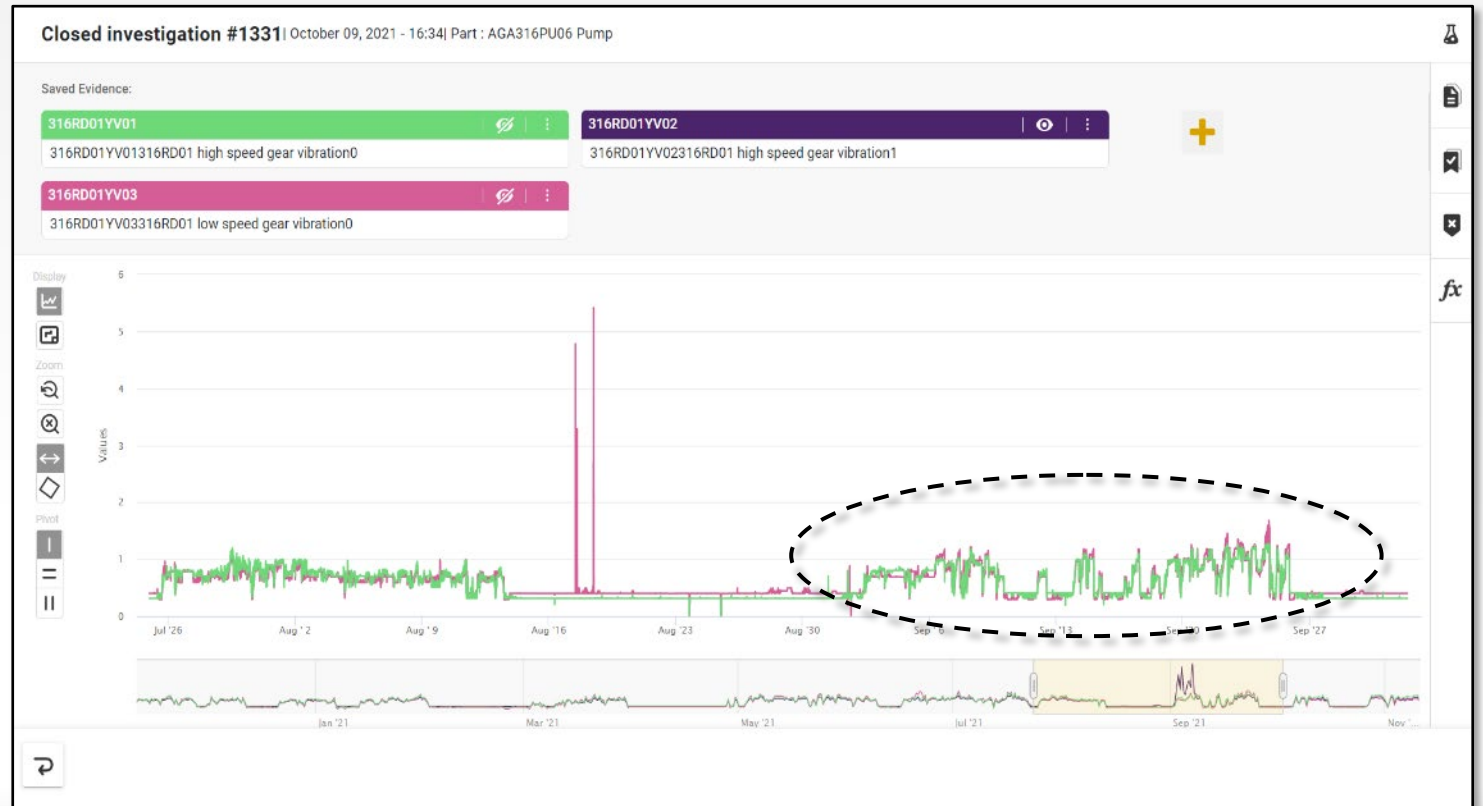
- Vibration increase on main reducer of kiln drive
- No indications nor alarms in the plant control room

- Loose pinion bolts connecting one drive on the reducer

- Field inspection of drive and reducer.

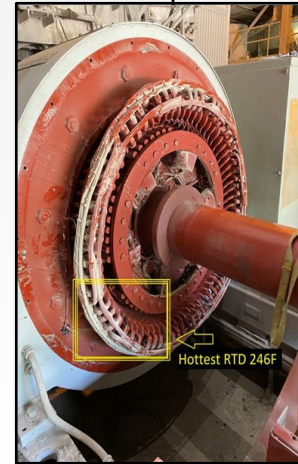
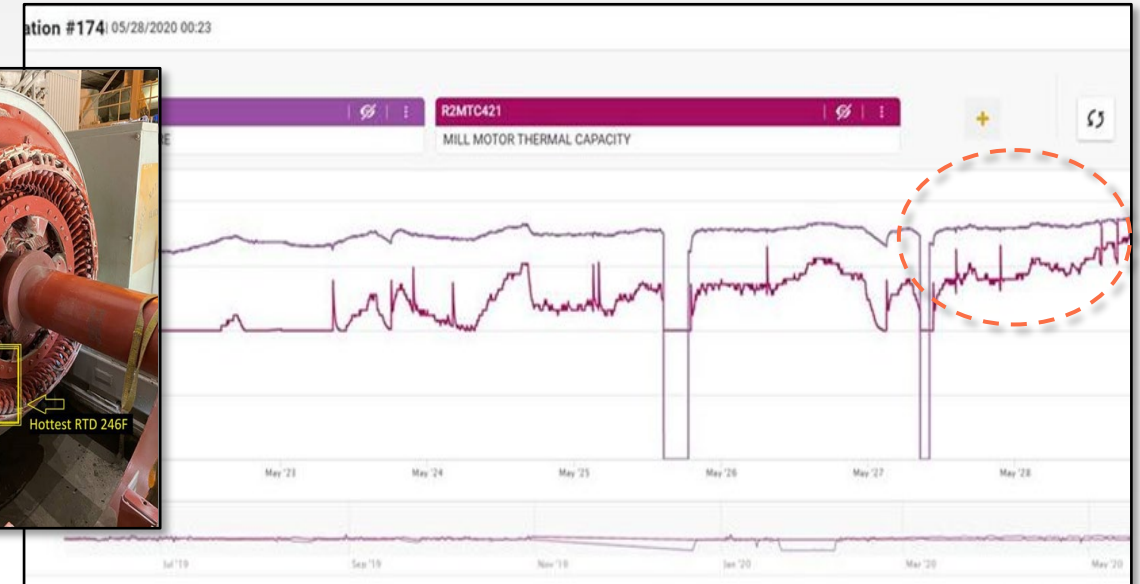
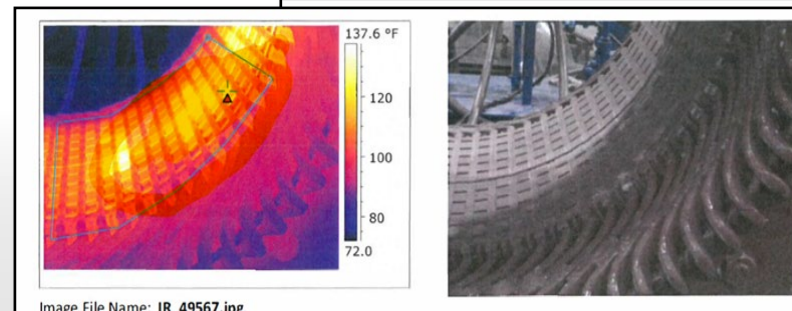
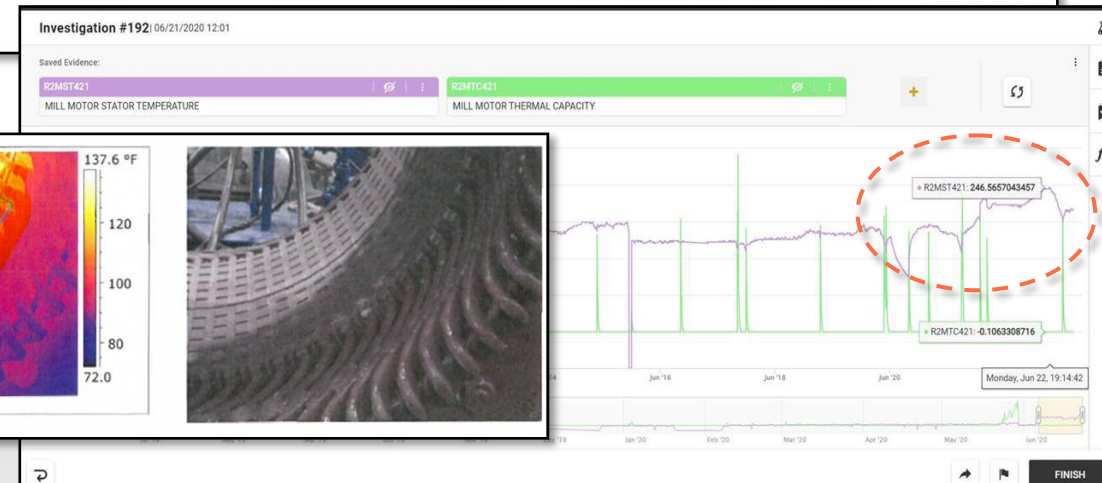
- Temperature Increase in the mill motor windings
- No alarms in the MCC or the plant control room

- After thorough inspection it was found that one of the stator RTDs was failing and was scheduled for replacement. No issues were identified with the motor windings.
- Found that signals from the motor RTDs were not transferred to the control room screens so the operator would have no knowledge of motor temperature issues. Connections were established with proper interlocks for motor protection

- Plant electrical dept was alerted of the change with a recommendation to inspect the motor and recommended a thermal scan of the motor while in operation to identify any hot spots on the housing

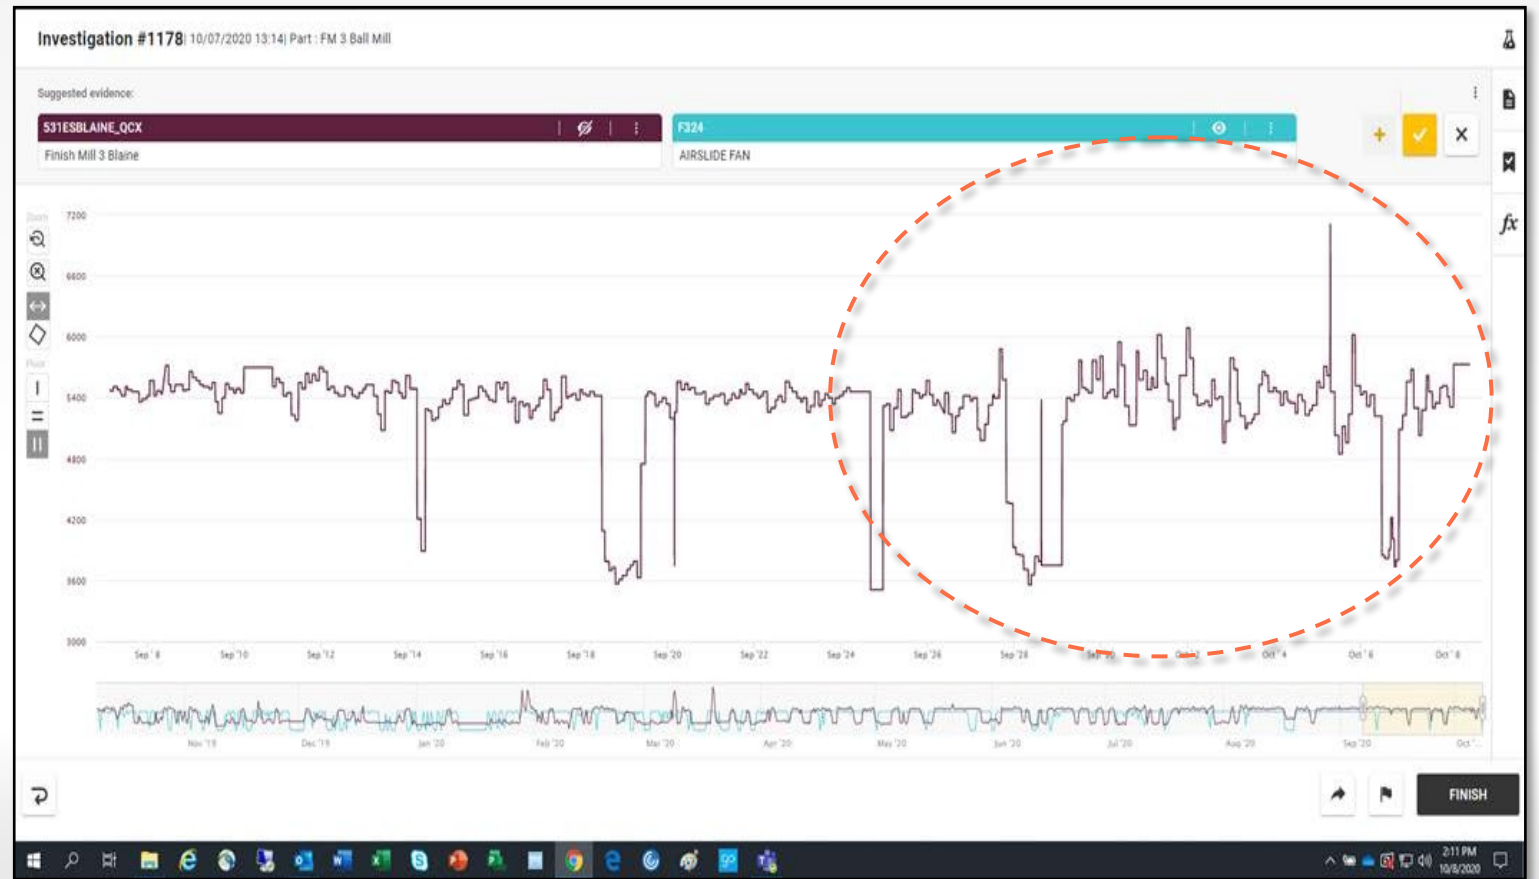
- Cement Blaine deviation increased significantly
- No indications nor alarms in the plant control room

- Feed clinker mix had been changed. Increased ground clinker percentage had resulted to feeding flowability issues and eventually to increased Blaine deviation

- Avoid quality issues and restore proper feeding by reviewing clinker mix and optimizing with respect to feeding flowability and Blaine deviation targets

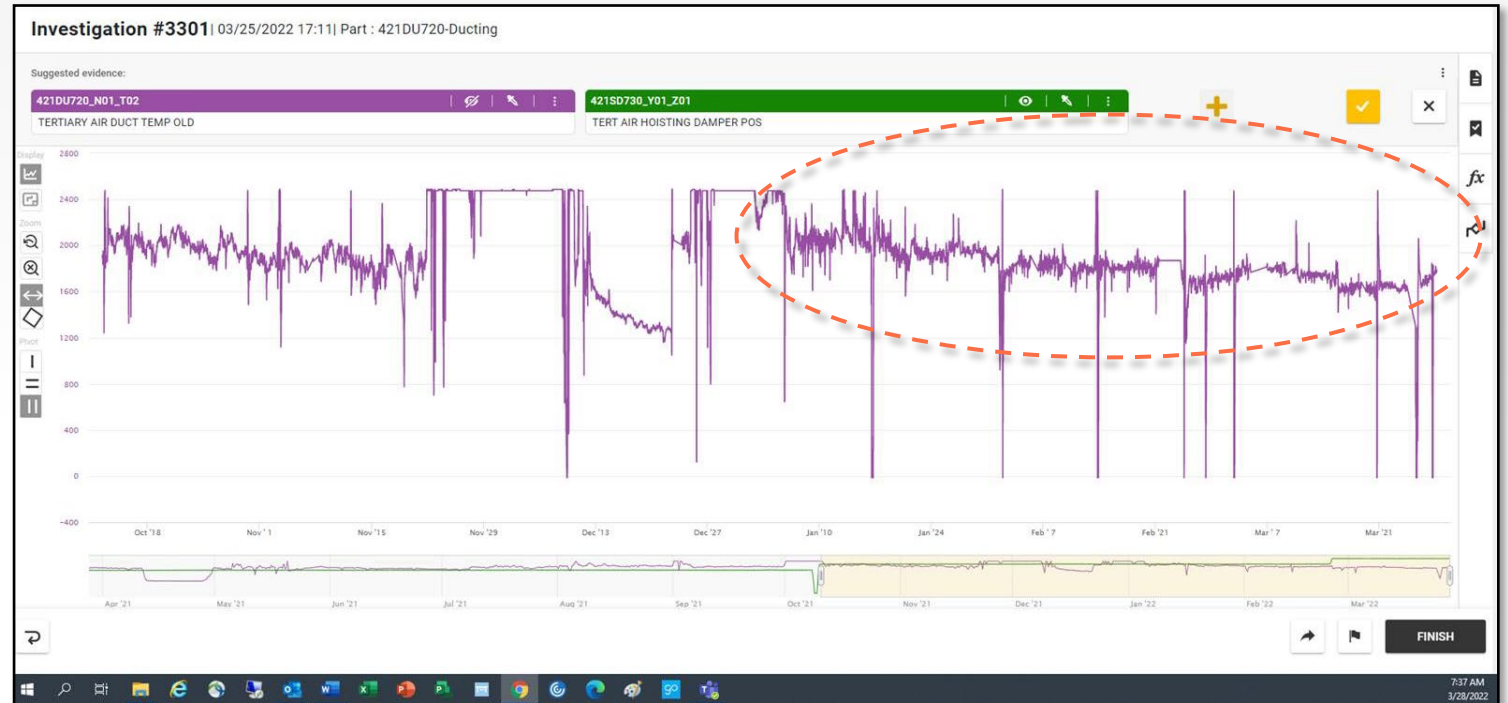
- Gradual Tertiary duct drop
- No alarms in the plant control room because there is no interlock

- Clinker cooling process reviewed (Cooler fans dampers) & TA damper position. Signal is not interlocked.
- Efforts to reduce NOx by reducing Oxygen have been taken

- Field inspection of TA damper operation
- Process data investigation on Clinker Cooler operation and NOx

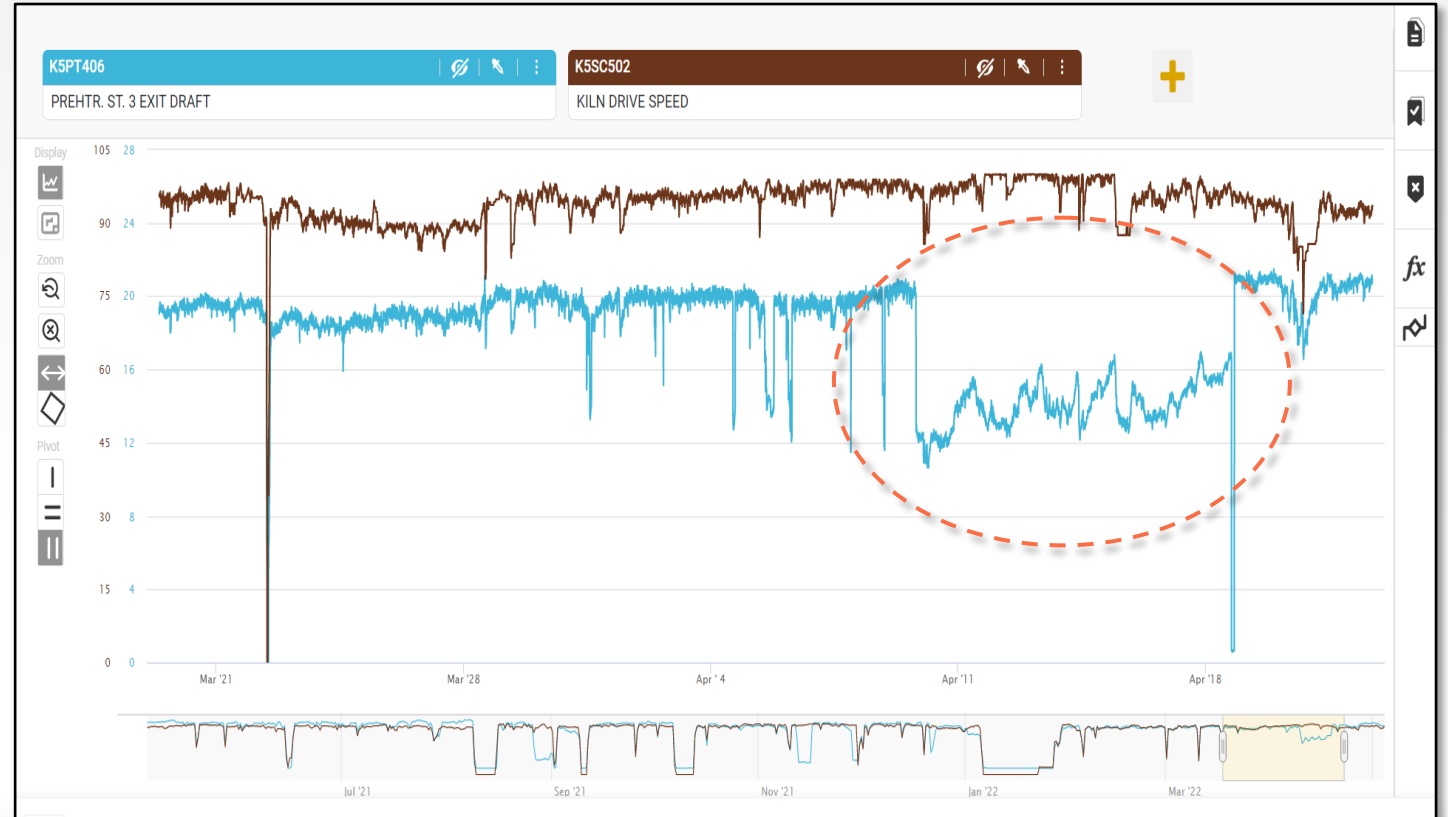
- PH stage 3 cyclone exit draft dropped
- No alarms in the plant control room because there is no interlock

- Pressure indication was faulty due to instrument plug. Instrument cleaned and proper indication was restored.

- Field inspection for cyclone build ups at Stage 2 & Stage 3
- Process data analysis comparing with temperatures and blockage nuclear indications
