# Event I: Kiln Pier #1 Oil Temp - Lubrication

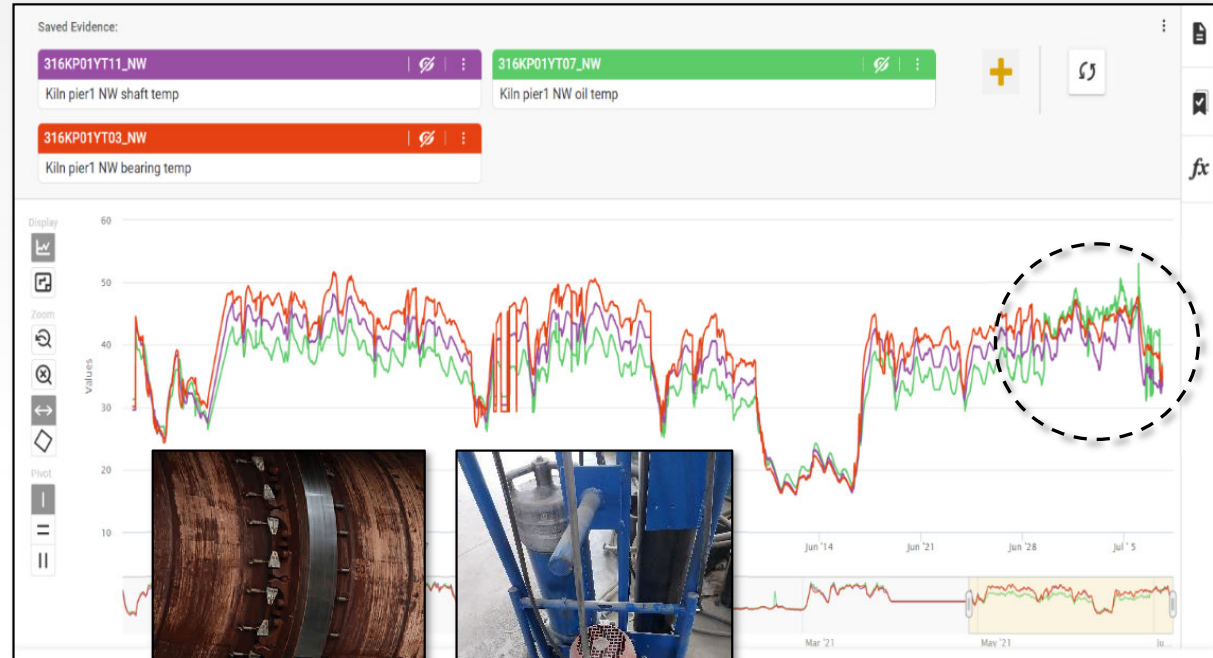
- Temperature increase in Pier #1 of kiln (still within limits)
- No indications nor alarms in the plant control room

- External oil leakage was found at the oil cooler.
- Bearing still not dry and oil level still in operational range (no level alarm triggered)
- Plant team isolated the cooler and refilled oil tank.
- Oil cooler replaced and full operation was restored
