Event II: Vertical Roller Mill Separator

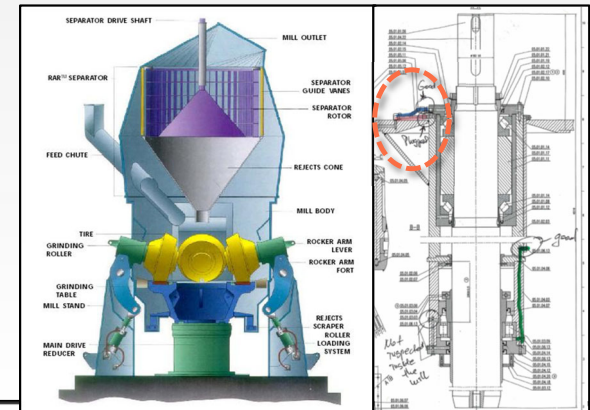
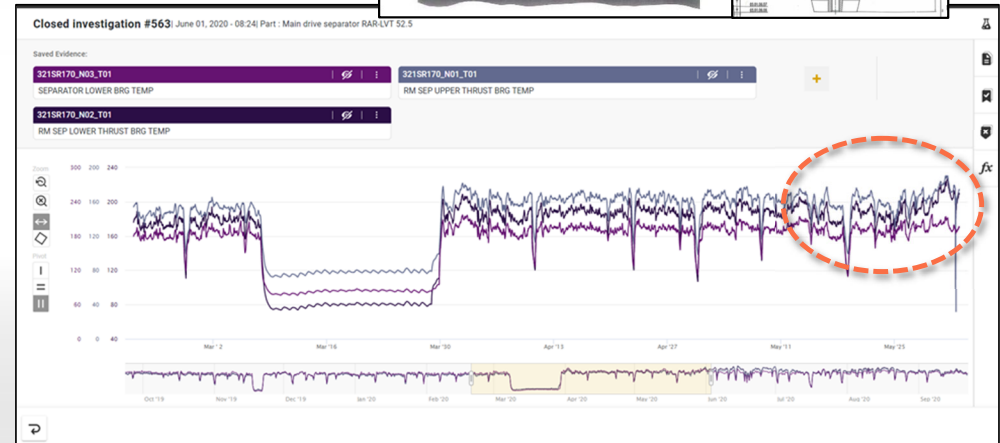
- Moderate temperature increase in separator shaft bearings
- No indications (alarms) in the plant control room

- Grease distributor was found clogged and was replaced
- Temperature still elevated so it was suggested to disconnect all lines and check if lubricant is flowing
- One of the grease lines was found clogged and cleaned
- Bearing temperature back to normal levels
- Bearing damage avoided b/c event was captured at very early stages

- Inspect automatic lubrication system
- Check for unusual vibration levels or noise
