Event III: High Speed Bearing - Vibration

CemAI Event Feedback

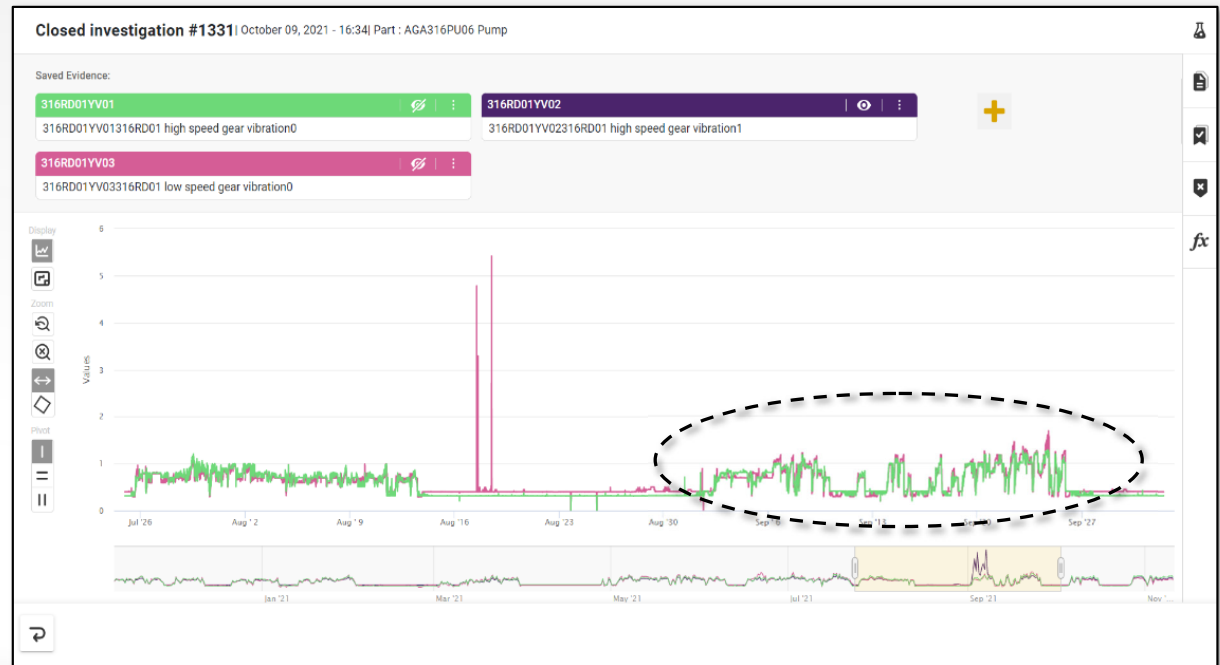
- Vibration increase on main reducer of kiln drive
- No indications nor alarms in the plant control room

- Loose pinion bolts connecting one drive on the reducer

- Field inspection of drive and reducer.
